# Manhole Inspection Summary

Manhole # S37W1\_030MH

Insp Date: **11/29/07 10:40 AM**

**Location** Address: **216 Pontiac Ave**

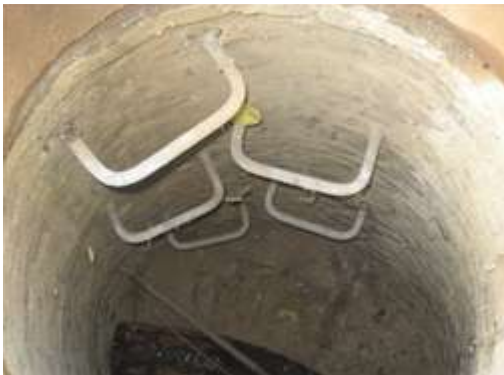
Steps

**Steps** Count: **5** Missing: **0** ☐ Corroded

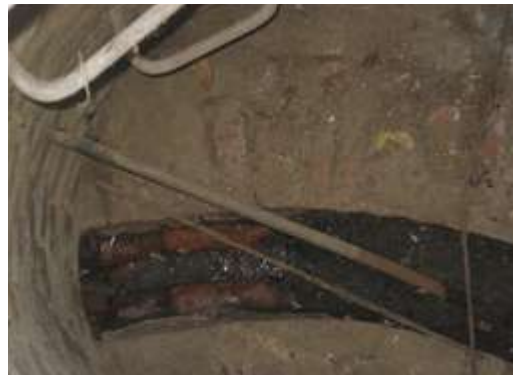
Defect 2

Pole in channel

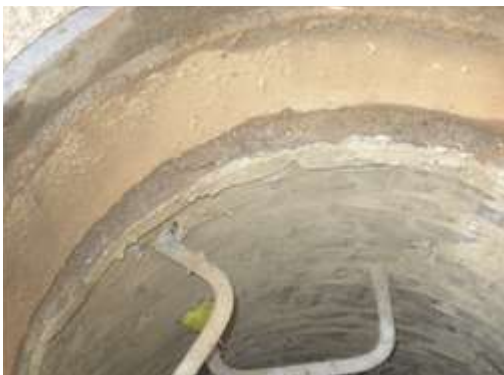
Defect 1

**Frame** Offset: **1.5** (in.) Condition: ☒ Sound ☐ Cracked ☐ Leaks

Frame offset

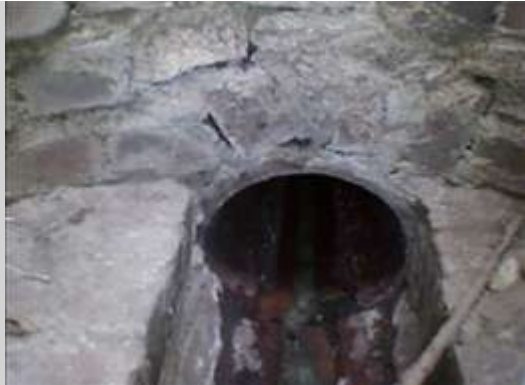
12 O'Clock Outflow

10 in. Circular Gravity Sewer  
Pipe Out @ 12 O'Clock

Pipe Height: **10.8** (in.) Rod and Bar (Angled)  
Pipe Material: **Clay** ☐ Pipe Lined  
Invert Depth: **8.80** (ft.) Flow Characteristics: **None**  
Deposits: ☒ None ☐ **Mud** ☐ Sludge ☐ **Debris** ☐ Grease  
Silt Depth: (in.) Deposits Extent:  
Infiltration: **None** Pipe Seal Cond: **Sound**

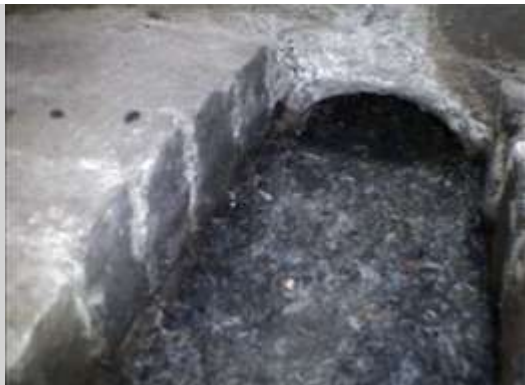
7 O'Clock Inflow

4 in. Circular Service Sewer  
Pipe In @ 7 O'Clock

Pipe Height: **3.6** (in.) Rod and Bar (Angled)  
Pipe Material: **Clay** ☐ Pipe Lined  
Invert Depth: **1.00** (ft.) Flow Characteristics: **None**  
Deposits: ☐ None ☒ **Mud** ☐ Sludge ☒ **Debris** ☐ Grease  
Silt Depth: **10** (in.) Deposits Extent: **Heavy**  
Infiltration: **None** Pipe Seal Cond: **Sound**
